DEPARTMENT OF TRANSPORTATION

Quality Assurance and Source Inspection

Contract #: 04-0120F4Cty: SF/ALA Rte: 80 PM: 13.2/13.9File #: 99.28**WELDING INSPECTION REPORT****Resident Engineer:** Casey, William**Address:** 333 Burma Road**City:** Oakland, CA 94607**Report No:** WIR-029986**Date Inspected:** 07-Sep-2013**Project Name:** SAS Superstructure**OSM Arrival Time:** 600**Prime Contractor:** American Bridge/Fluor Enterprises, a JV**OSM Departure Time:** 1430**Contractor:** Steward Machine Co.**Location:** Birmingham, AL**CWI Name:** Fred Hudson**CWI Present:** Yes No**Inspected CWI report:** Yes No N/A**Rod Oven in Use:** Yes No N/A**Electrode to specification:** Yes No N/A**Weld Procedures Followed:** Yes No N/A**Qualified Welders:** Yes No N/A**Verified Joint Fit-up:** Yes No N/A**Approved Drawings:** Yes No N/A**Approved WPS:** Yes No N/A**Delayed / Cancelled:** Yes No N/A**Bridge No:** 34-0006**Component:** E2 Shear Key Anchorages**Summary of Items Observed:**

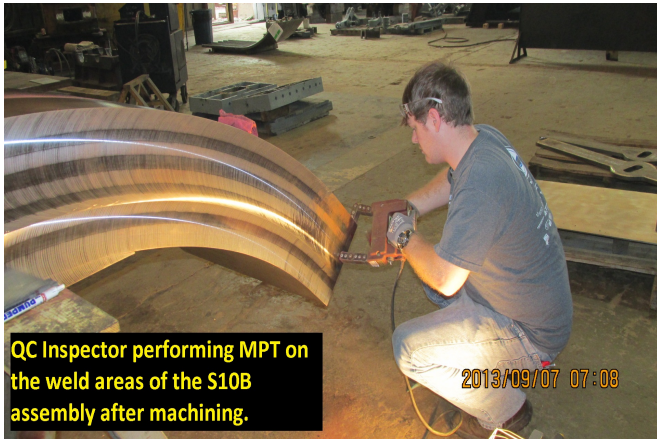
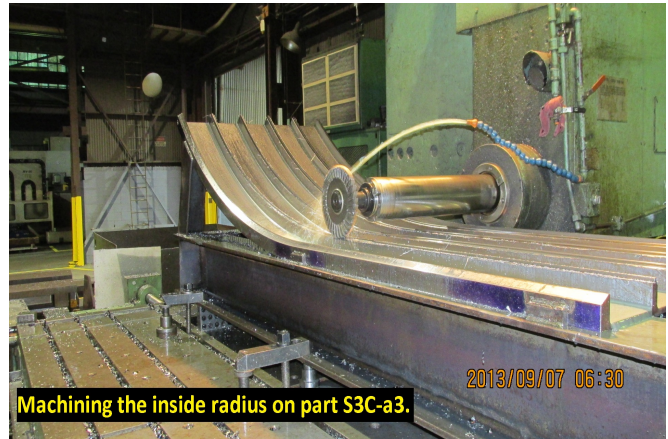
This QAI noted the welding of the b10 plates to the S10B assembly. The welding was done by qualified welder Daniel Rowe (73). The welding was done to the approved welding procedure (WPS) P2-W128-B. All welding done was monitored by Certified Welding Inspector (CWI) Fred Hudson. After the root pass was welded in all four lugs Magnetic Particle Testing (MPT) was performed by the QC Inspector and this QAI. During the cooling of the welds it was noted by the welder that the lug plates were out of square to the part. The S10B was moved to a table where clamps were applied to the lugs to hold keep them from moving out of square more. During welding welder Daniel Rowe checked the square of the lugs and made adjustments to the clamps to keep them in square to the S10B assembly.

During the welding of the b10 lugs to the S10B assembly this QAI voiced his concern to SMR Courtney Goldstein of the d1 plate expanding during the welding process and possible cracking the PJP weld that will connect two of the b10 lugs to the S10B assembly. SMR Ms. Goldstein took this QAI's concern and relayed it to SMR Aaron Prchlik.
